## COLORADO CULTURAL RESOURCE SURVEY

**Architectural Inventory Form**

1. Resource number: **5SM.1677**  
 2. Temporary resource number: **N/A**  
 3. County: **San Miguel**  
 4. City: **Telluride**  
 5. Historic Building Name: **Unknown**  
 6. Current Building Name: **Gunty House**  
 7. Building Address: **425 W. Pacific Avenue**

47. Photograph number(s): **CD #5, Images 593-600** CDs filed at: **Town of Telluride**
48. Report title: **Town of Telluride Re-Survey of Historic Structures** **Planning and Building**  
**Department**
49. Date(s): **09/01/2007; revised 4/10/2012** **113 West Columbia Avenue**
50. Recorder(s): **Carl McWilliams** **Telluride, CO 81435**  
**Timothy Wilder**
51. Organization: **Cultural Resource Historians**
52. Address: **Dogwood Court**  
**Fort Collins, CO 80525**
53. Phone number(s): **(970) 493-5270**

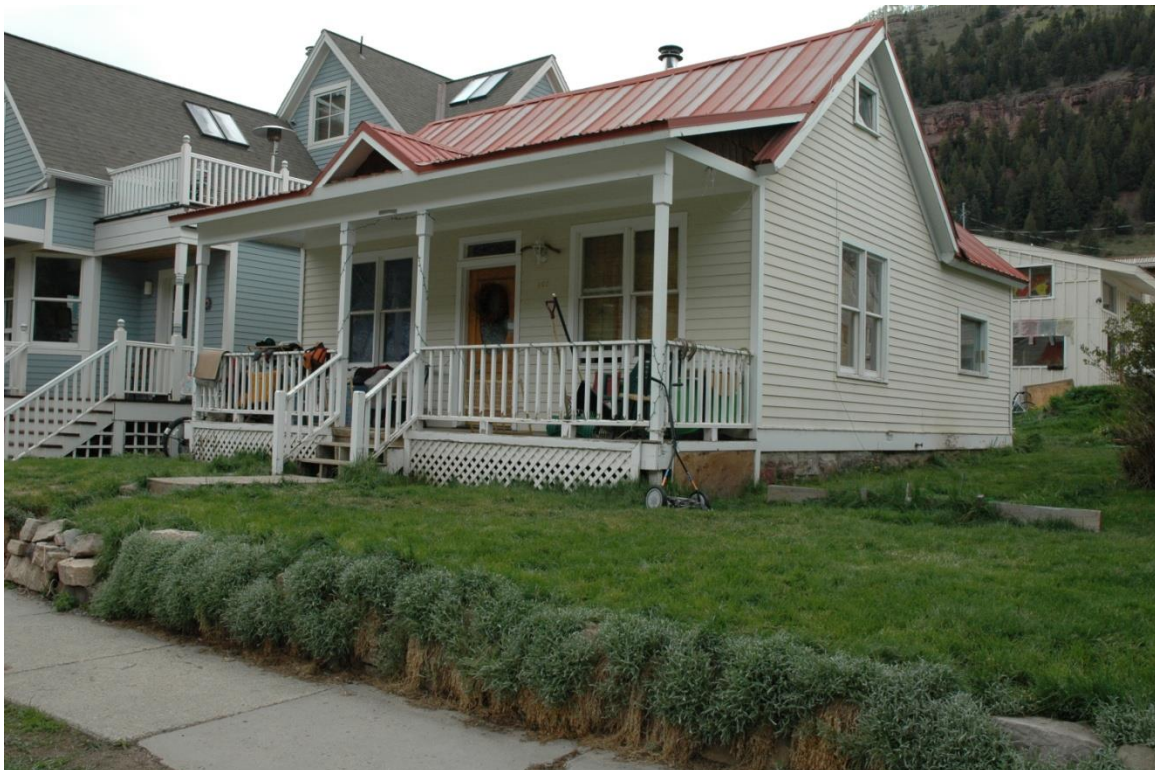
**This is a 1½-story wood frame cross gabled dwelling. The house rests on a low coursed sandstone foundation, partially covered with concrete pargeting, and its exterior walls are clad with painted cream white horizontal weatherboard siding with 1" by 4" corner boards. The gable roof is moderately-pitched, and is covered with red metal roofing material. The eaves are boxed with painted white wood trim, and a red brick chimney is located on the roof ridge. The symmetrical façade faces toward Pacific Avenue on the north elevation. A non-historic stained brown wood-paneled front door, with an oval light and a transom light, enters the center of the façade from a non-historic full-width front porch. This porch is approached by two wooden steps, and features a tongue-in-groove wood floor, an open painted white wood railing, 4" by 4" wood posts, and a shed roof with a small intersecting gable over the entry stairs. A white metal-paneled door, with one upper sash light, enters an enclosed shed-roofed mud porch on the south (rear) elevation. The house's original windows are single and paired 1/1 double-hung sashes, with painted white wood frames and surrounds. A non-historic single-light window is located near the north end of the east elevation. Another non-historic 2-light window is located in the south elevation's upper gable end.**

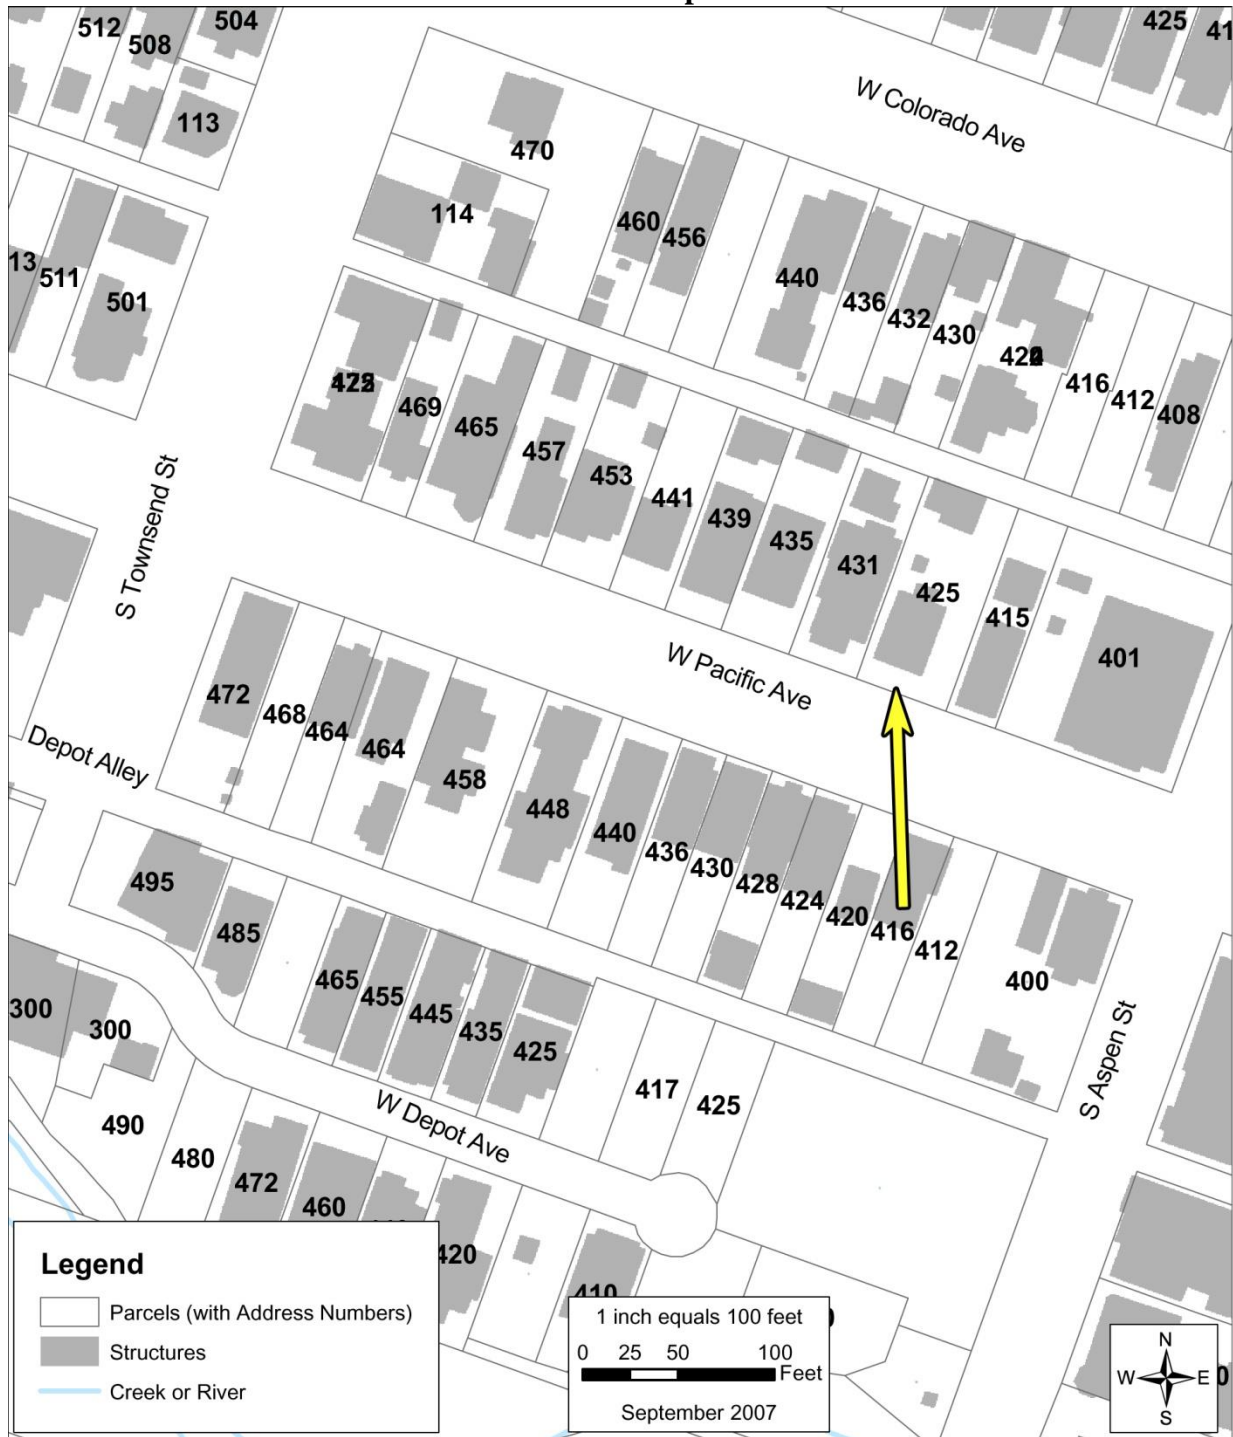
## Sketch Map

23. Landscape or special setting features: **This property is located on the north side of Pacific Avenue in the block between Aspen and Townsend Streets.**

A non-historic secondary residence is located adjacent to the alley at the north end of the property. This building is composed of a main two-story shed-roofed section, which measures approximately 20' N-S by 12' E-W, and a lower one-story shed-roofed extension to the west elevation, which measures approximately 14' N-S by 12' E-W. This building rests on a concrete block foundation, and its exterior walls are made of painted cream yellow board and batten. The shed roofs are covered with corrugated metal, and the eaves are boxed with painted cream yellow wood trim. A painted cream yellow solid wood door enters the east elevation. Another painted cream yellow solid wood door enters the south elevation from an uncovered wood porch. This building has horizontally-oriented 1x1 horizontal sliding and single-light fixed-pane windows.
